Asset Management in the Water/Wastewater Industries:

A Case Study from the Upper Occoquan Service Authority (UOSA) in Centreville, VA

Mike Matichich
FTA State of Good Repair Roundtable
Chicago, Illinois
July 22, 2010

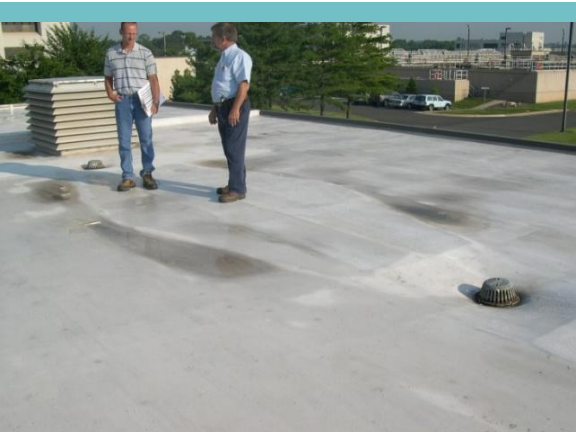
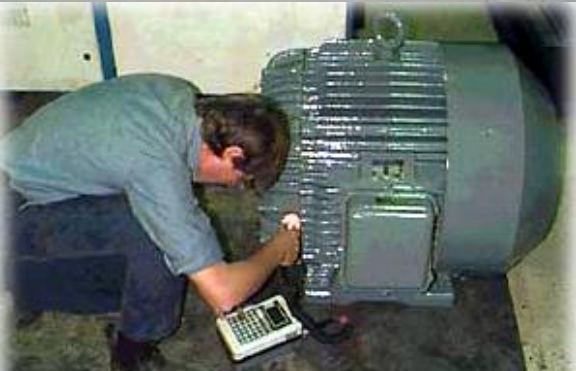
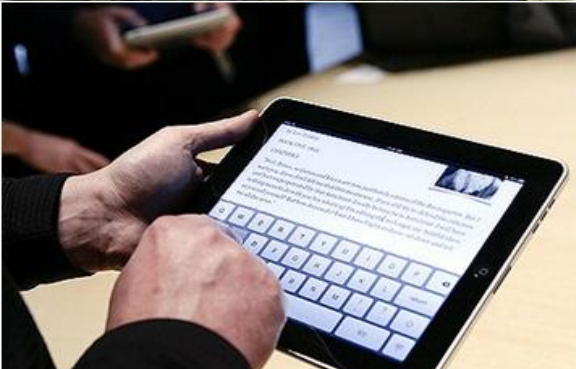
Condition assessments were conducted using a step-by-step process that can be sustained

1. Asset data and history were gathered
2. Assessment criteria were developed with UOSA for each type of asset
3. Information was uploaded to CH2M HILL's Asset Condition Evaluation System (ACES) tool
4. Field condition assessments were conducted
5. Risk results were calculated

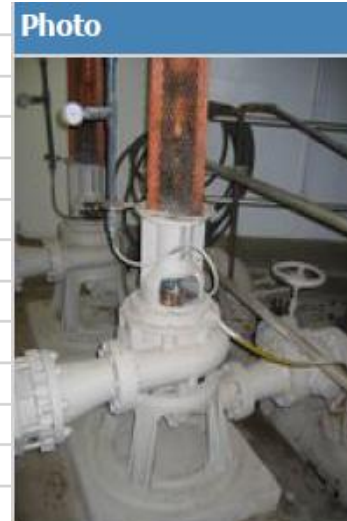
UOSA Asset Condition Assessment

This example illustrates specific questions by asset type and how answers were documented

Asset	160	Location	Digester Complex Buildings (C1)
Parent Number	0503030000	System	0503020402
Asset Description	PUMP CENT	Inspection Date	6/19/2008 12:00:00 AM
Comments	Picture 60

Question	Answer		NA	Flag	Answer Comment
Vibration Measurement	2	2 -Good .039 - .15 inches/sec			.1 in / sec
Mounting	2	Good			
All Safety Guards Present	1	yes			
Acceptable Noise	1	yes			
Absence of Pump Cavitations	1	yes			
Absence of Leaks	1	yes			
All Components	1	yes			
Lubrication OK at Inspection	1	yes			
No Mechanical Seal Leakage			X		
Operating at Inspection	1	yes			
Corrosion - Structural Metals	2	Slight staining/small chips			
Infrared	1	Negligible Ambient			
Packing Gland/Seals	2	Normal			
Pipe Alignment	1	Straight			
Belt/Direct Drive/Couplings	2	Minor Wear			
Gauges Operational			X		
Obsolesence	1	Currently supported

Condition Score

1.429

Condition Category

Very Good No corrective maintenance needed
